Technical Memorandum

RE: Nielsville Bridge Deck Inspection Findings

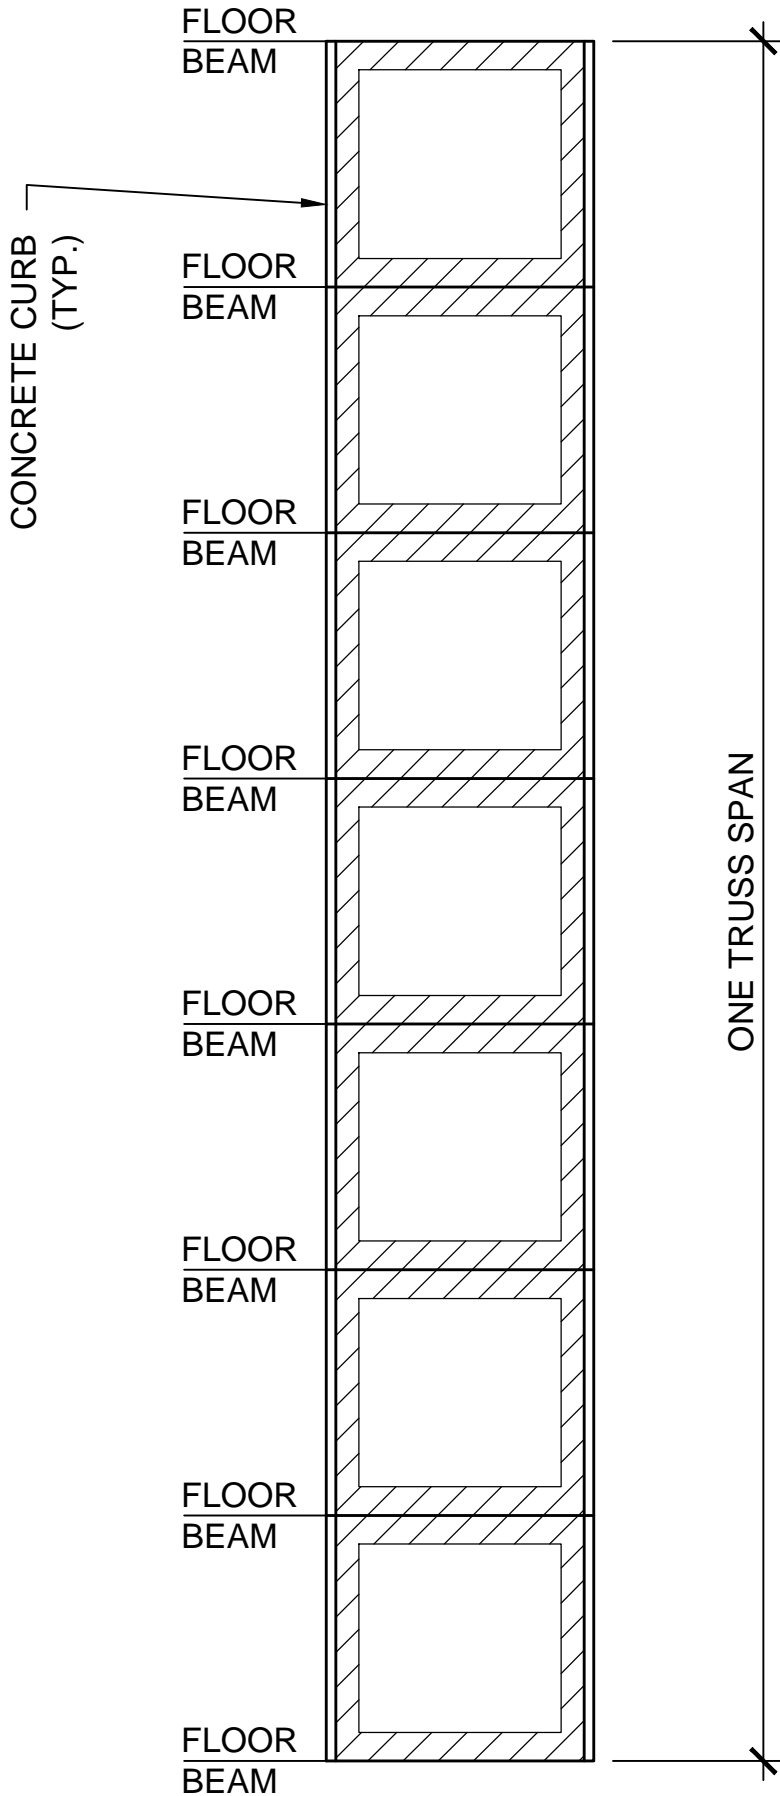
EXHIBIT A

Unsound concrete was detected around all of the asphalt-patched areas near floor beams and typically extended 3'-4' beyond the patching limits. The hole that has already developed was at one such patched area over a floor beam. Unsound concrete was also detected inside both curbs for the entire length of the bridge. These areas seemed to range from 2'-3' inside the curbs. The attached exhibit (Exhibit A) shows the approximate areas where unsound concrete was discovered. Based on this initial survey, the percentage of the concrete deck that may contain unsound concrete ranges between 40%-50%.

APPROXIMATE AREA
OF UNSOUND CONCRETE

A chain survey will not reveal the depths of the unsound concrete. Based on the hole that that recently formed in the deck, it is likely that the deteriorated concrete extends nearly full depth in the areas over the floor beams. Depths of the unsound concrete would have to ultimately be verified with concrete coring. At this point, our recommendation is to further investigate the extent of deterioration of the concrete deck prior to initiating any repairs or reopening the bridge.
